COMMERCIAL WINDSTORM MITIGATION REPORT (OIR-B1-1802)

Key Manor Condominium Association, Inc.
3122 30th Ave N, Building A, Units 101-105, 201-205
St. Petersburg, FL 33713

As of 7/22/2019
FPAT File# MUD1913508

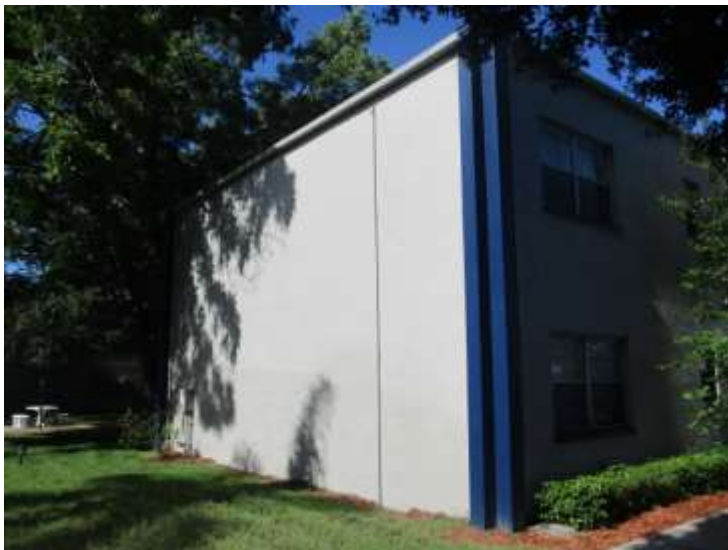
Exterior Elevation

7. **Opening Protection:** **None or Some Glazed Openings**
Comments: Inspection verified no opening protection.

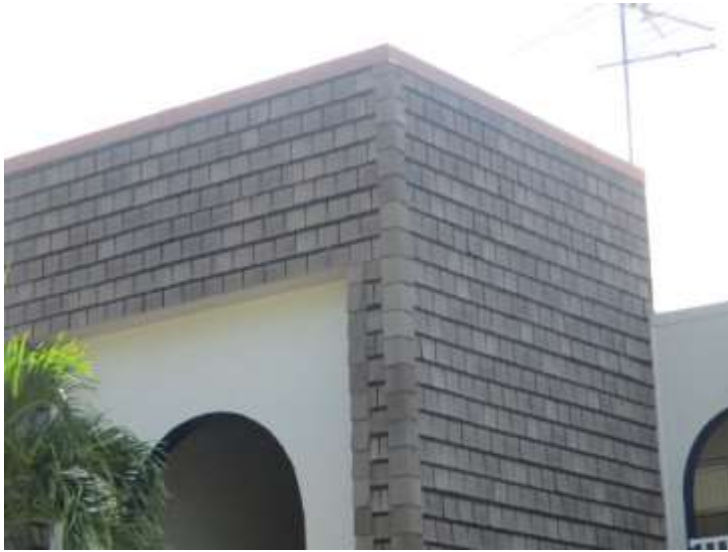
Roof Construction

3. **Roof Deck Attachment:** **Other**
Comments: Inspection verified a roof deck composed of lightweight concrete gypsum panels supported by steel bar joists.

4. **Roof to Wall Attachment:** **Structural**
Comments: Inspection verified a roof-wall connection composed of steel bar joists structurally connected to the wall/support system.
