COMMERCIAL WINDSTORM MITIGATION REPORT (OIR-B1-1802)

Key Manor Condominium Association, Inc.

3123 29th Ave N, Building B, Units 101-107, 201-207

As of 7/22/2019

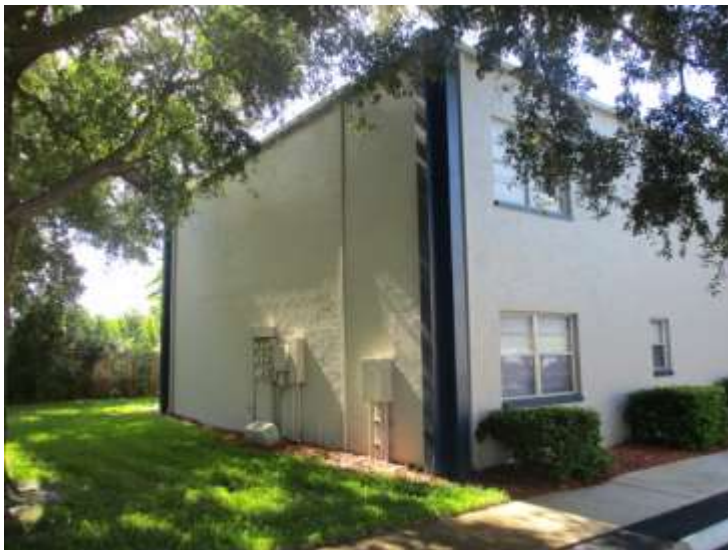
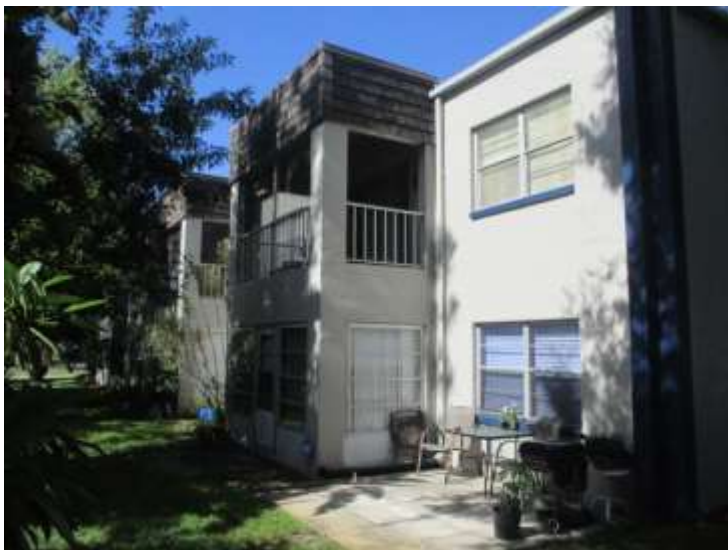
Exterior Elevation

5. **Roof Geometry:** **Flat Roof**
Comments: Inspection verified a flat roof shape.
6. **SWR:** **No**
Comments: Secondary water resistance does not apply to light weight concrete roof decks.

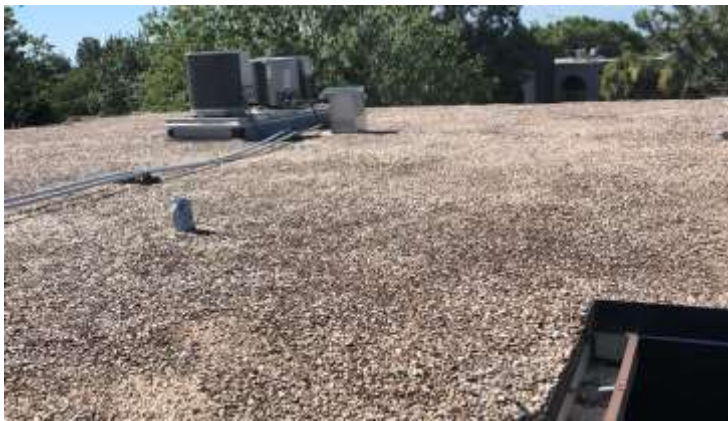
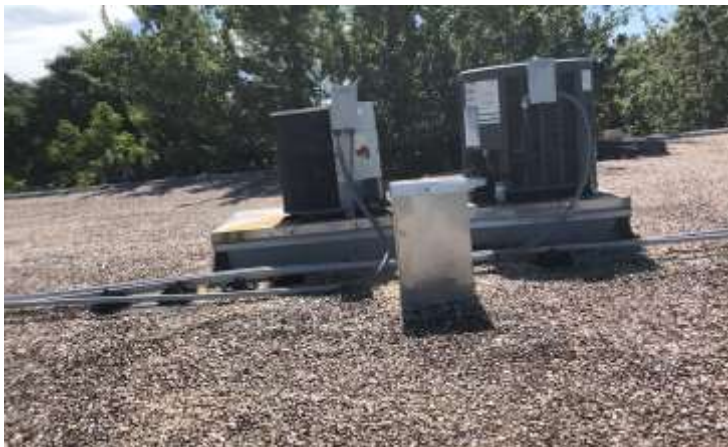
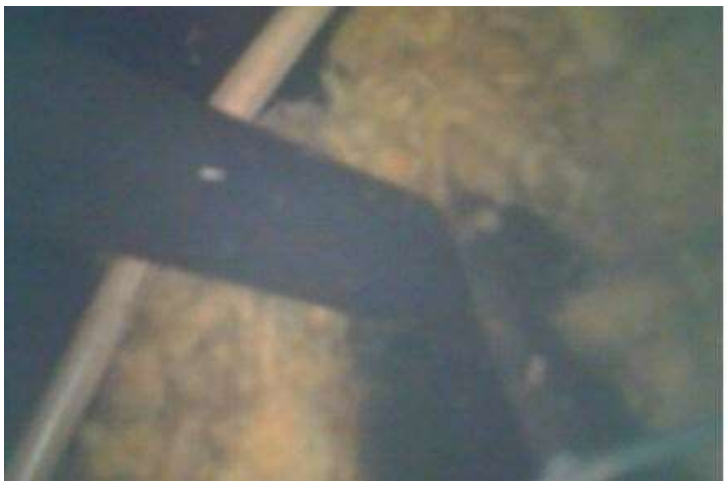
Roof Construction

3. **Roof Deck Attachment:** **Other**
Comments: Inspection verified a roof deck composed of lightweight concrete gypsum panels supported by steel bar joists.

4. **Roof to Wall Attachment:** **Structural**
Comments: Inspection verified a roof-wall connection composed of steel bar joists structurally connected to the wall/support system.
