COMMERCIAL WINDSTORM MITIGATION REPORT (OIR-B1-1802)

Key Manor Condominium Association, Inc.
3147 29th Ave N, Building C, Units 101-107, 201-207
St. Petersburg, FL 33713

As of 7/22/2019
FPAT File# MUD1913508

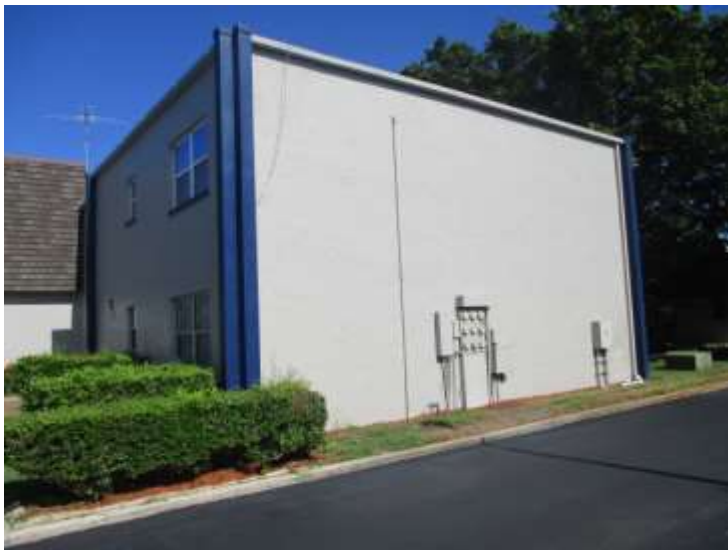
Exterior Elevation

7. **Opening Protection:** **None or Some Glazed Openings**
Comments: Inspection verified no opening protection.

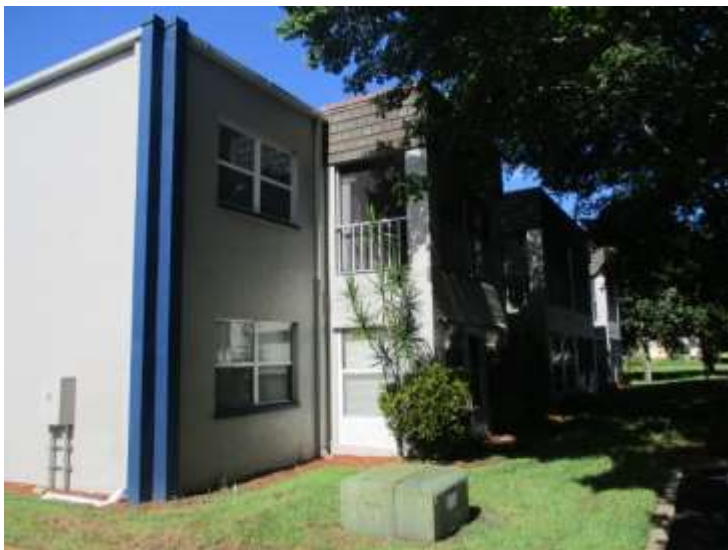
Exterior Elevation

5. **Roof Geometry:** **Flat Roof**
Comments: Inspection verified a flat roof shape.
6. **SWR:** **No**
Comments: Secondary water resistance does not apply to light weight concrete roof decks.

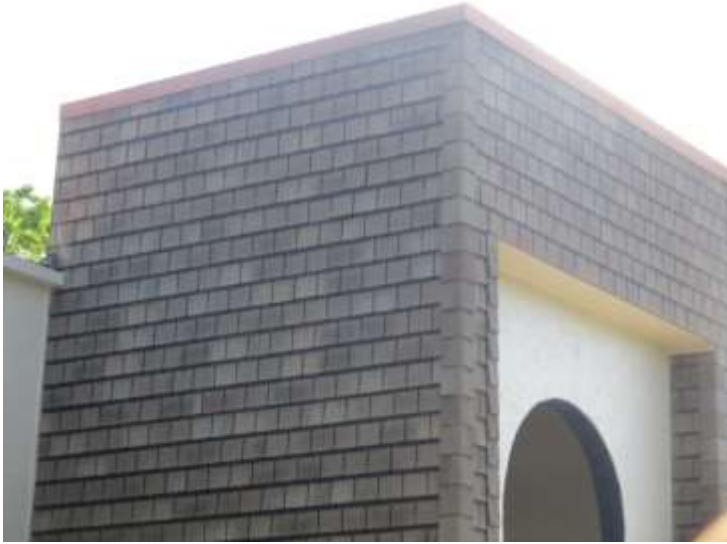
Roof Construction

3. **Roof Deck Attachment:** **Other**
Comments: Inspection verified a roof deck composed of lightweight concrete gypsum panels supported by steel bar joists.

4. **Roof to Wall Attachment:** **Structural**
Comments: Inspection verified a roof-wall connection composed of steel bar joists structurally connected to the wall/support system.
