COMMERCIAL WINDSTORM MITIGATION REPORT (OIR-B1-1802)

Key Manor Condominium Association, Inc.

3148 30th Ave N, Building D, Units 101-105, 201-205

As of 7/22/2019

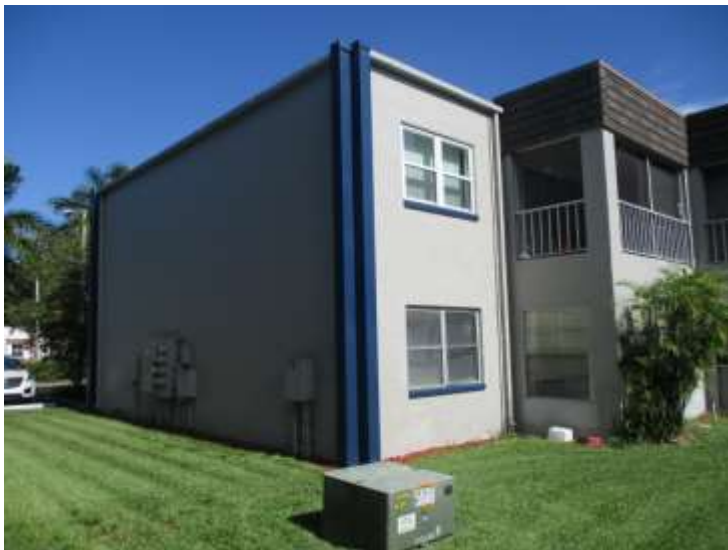
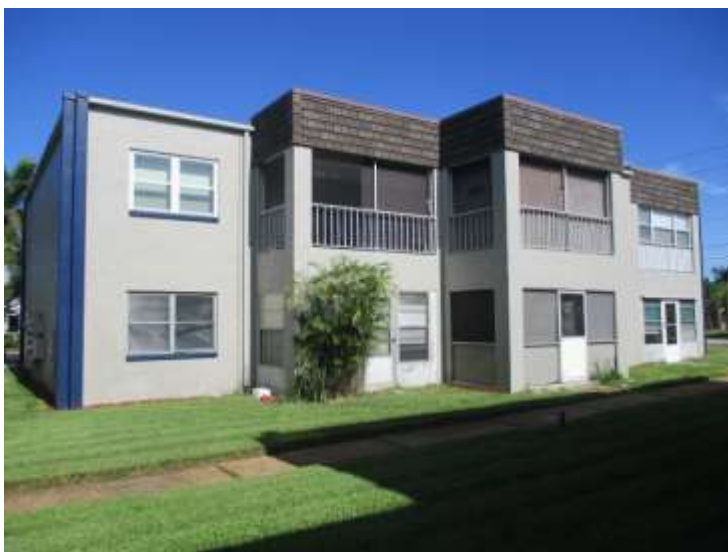
Exterior Elevation

5. **Roof Geometry:** **Flat Roof**
Comments: Inspection verified a flat roof shape.
6. **SWR:** **No**
Comments: Secondary water resistance does not apply to light weight concrete roof decks.

7. **Opening Protection:** **None or Some Glazed Openings**
Comments: Inspection verified no opening protection.

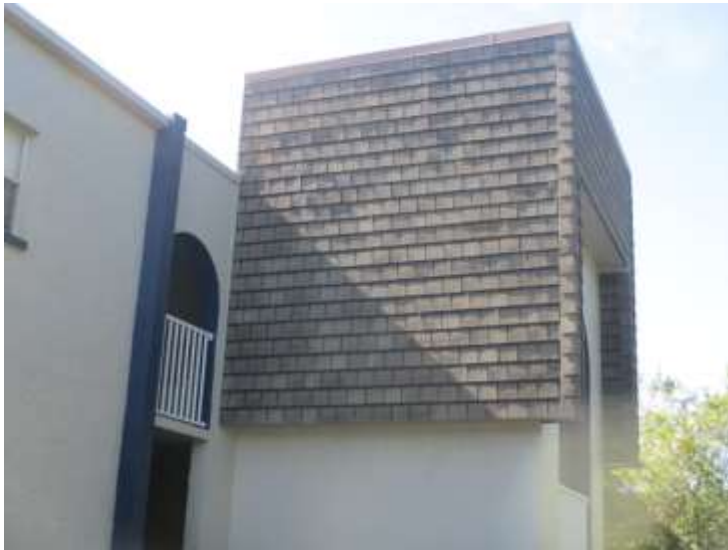
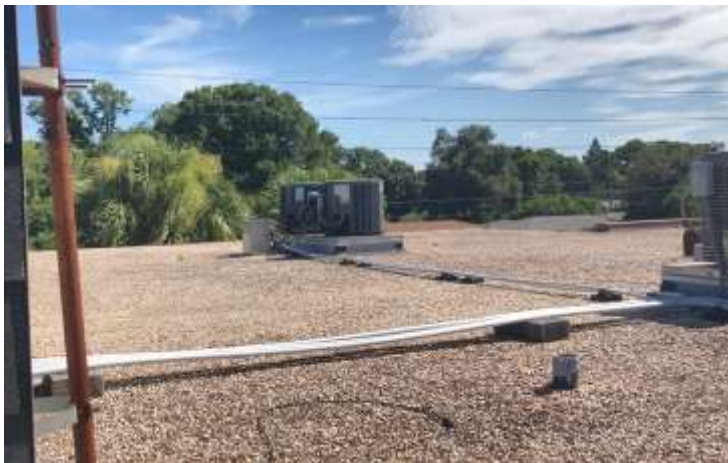
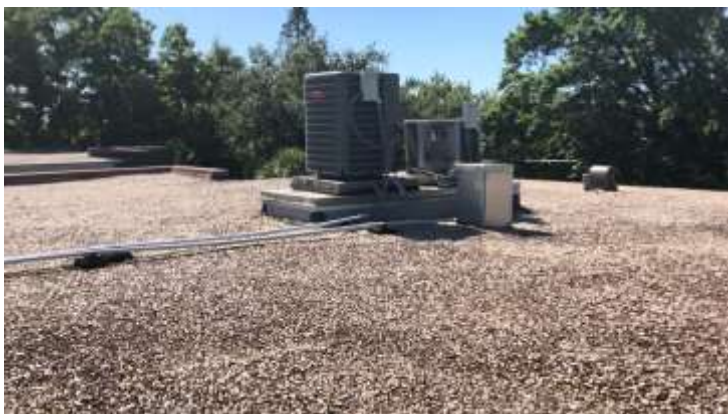
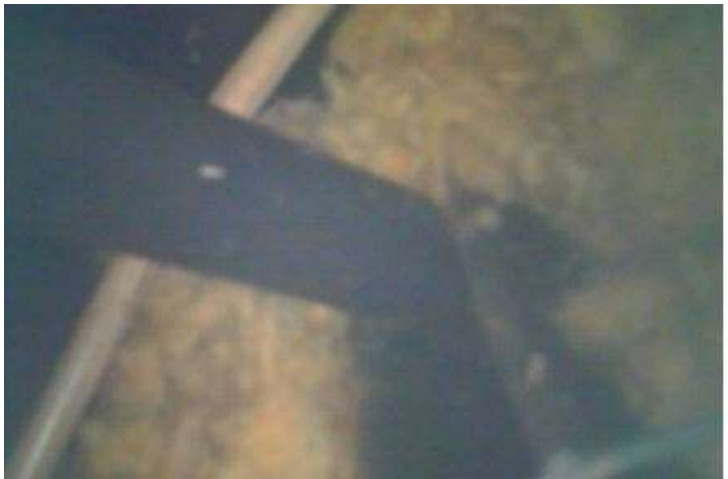
Roof Construction

3. **Roof Deck Attachment:** **Other**
Comments: Inspection verified a roof deck composed of lightweight concrete gypsum panels supported by steel bar joists.

4. **Roof to Wall Attachment:** **Structural**
Comments: Inspection verified a roof-wall connection composed of steel bar joists structurally connected to the wall/support system.
