## COMMERCIAL WINDSTORM MITIGATION REPORT (OIR-B1-1802)

Key Manor Condominium Association, Inc.  
3120 29th Ave N, Building E, Units 101-107, 201-207  
St. Petersburg, FL 33713

As of 7/22/2019  
FPAT File# MUD1913508

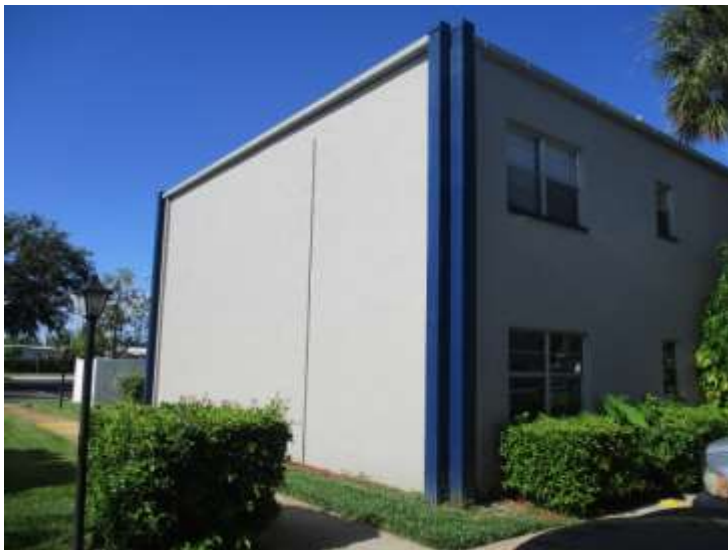
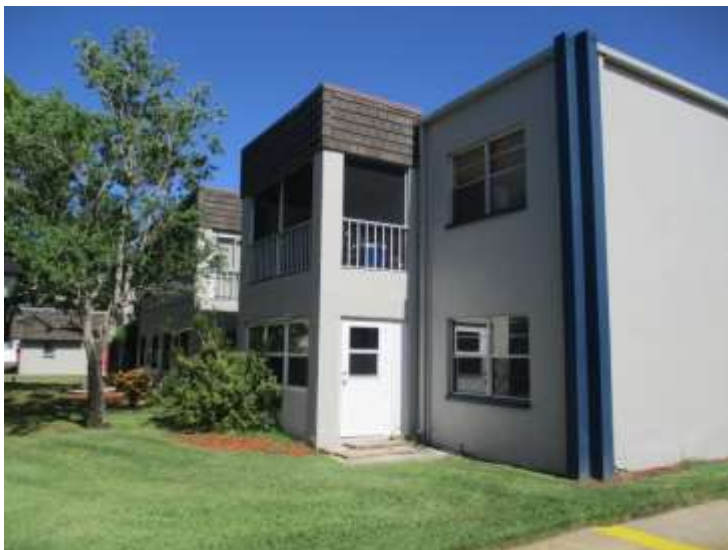
Exterior Elevation

7. **Opening Protection:**              **None or Some Glazed Openings**  
Comments:                                      Inspection verified no opening protection.

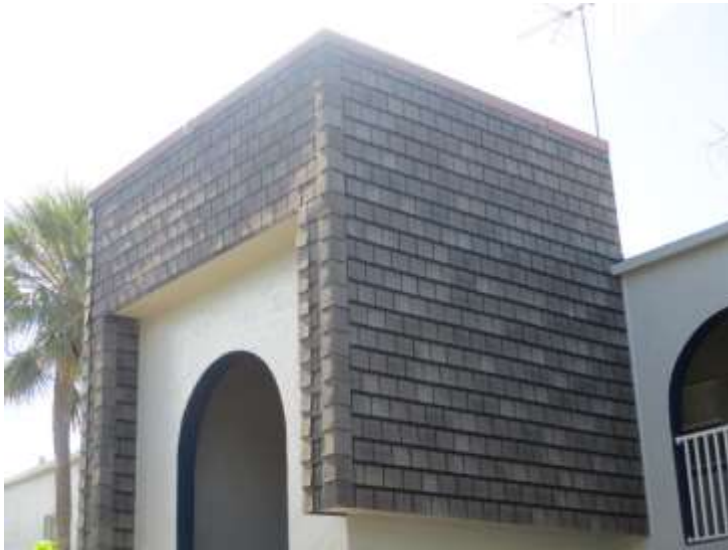
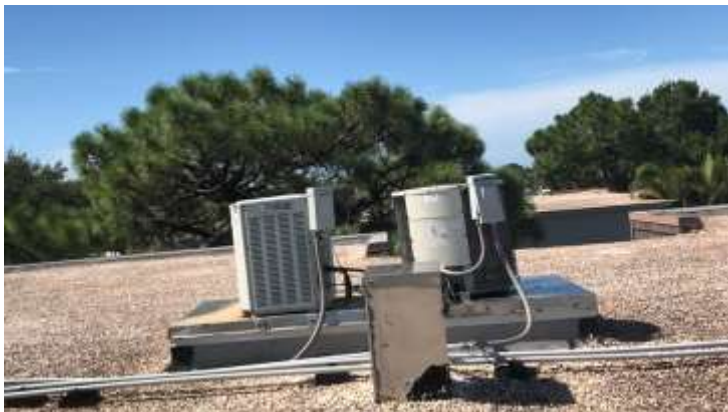
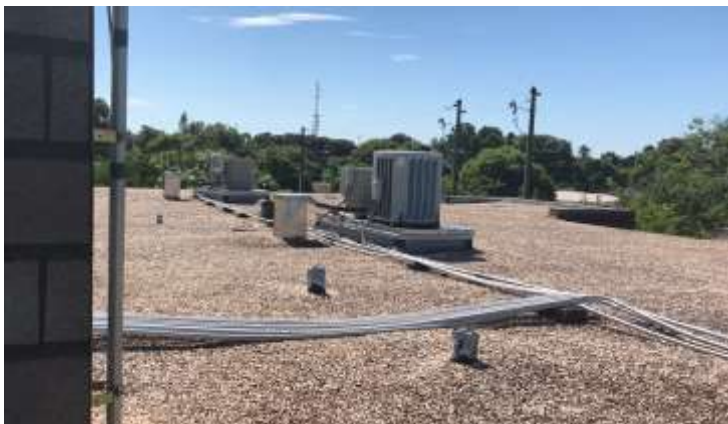
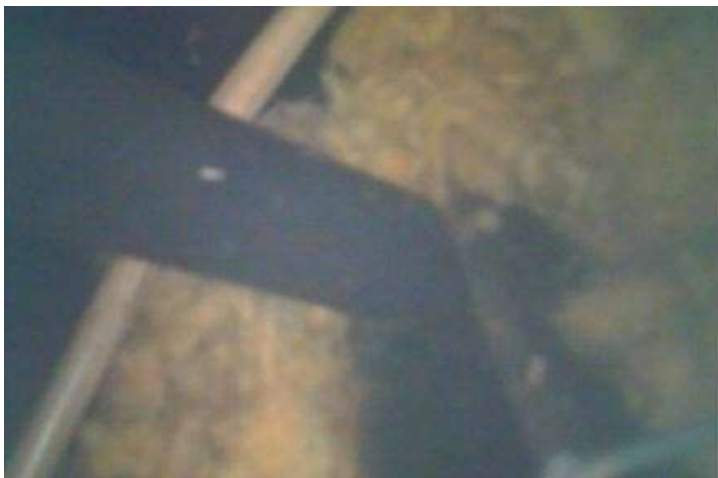
Roof Construction

3. **Roof Deck Attachment:**        **Other**  
Comments:                                      Inspection verified a roof deck composed of lightweight concrete gypsum panels supported by steel bar joists.

4. **Roof to Wall Attachment:**        **Structural**  
Comments:                                      Inspection verified a roof-wall connection composed of steel bar joists structurally connected to the wall/support system.

5. **Roof Geometry:**                      **Flat Roof**  
Comments:                                      Inspection verified a flat roof shape.

6. **SWR:**                                      **No**  
Comments:                                      Secondary water resistance does not apply to light weight concrete roof decks.
