COMMERCIAL WINDSTORM MITIGATION REPORT (OIR-B1-1802)

Key Manor Condominium Association, Inc.
3121 28th Ave N, Building F, Units 101-105, 201-205
St. Petersburg, FL 33713

As of 7/22/2019
FPAT File# MUD1913508

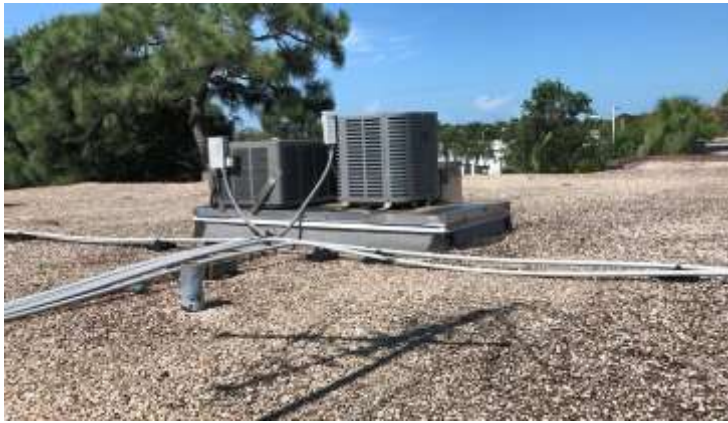
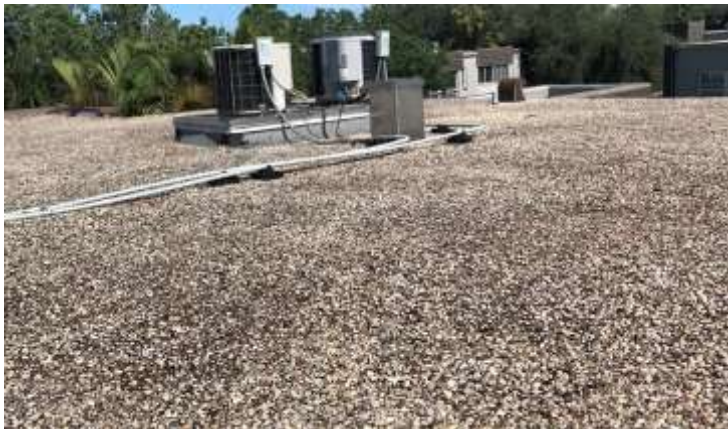
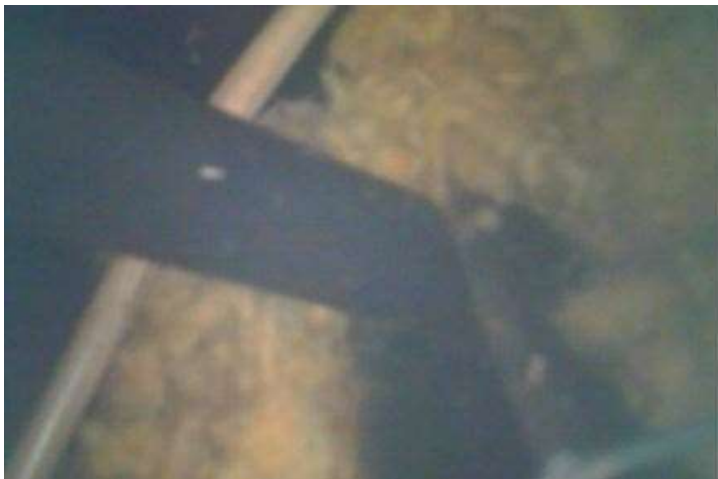
Roof Construction

3. **Roof Deck Attachment:** **Other**
Comments: Inspection verified a roof deck composed of lightweight concrete gypsum panels supported by steel bar joists.

4. **Roof to Wall Attachment:** **Structural**
Comments: Inspection verified a roof-wall connection composed of steel bar joists structurally connected to the wall/support system.

5. **Roof Geometry:** **Flat Roof**
Comments: Inspection verified a flat roof shape.
