COMMERCIAL WINDSTORM MITIGATION REPORT (OIR-B1-1802)

Key Manor Condominium Association, Inc.
3143 28th Ave N, Building G, Units 101-107, 201-207
St. Petersburg, FL 33713

As of 7/22/2019
FPAT File# MUD1913508

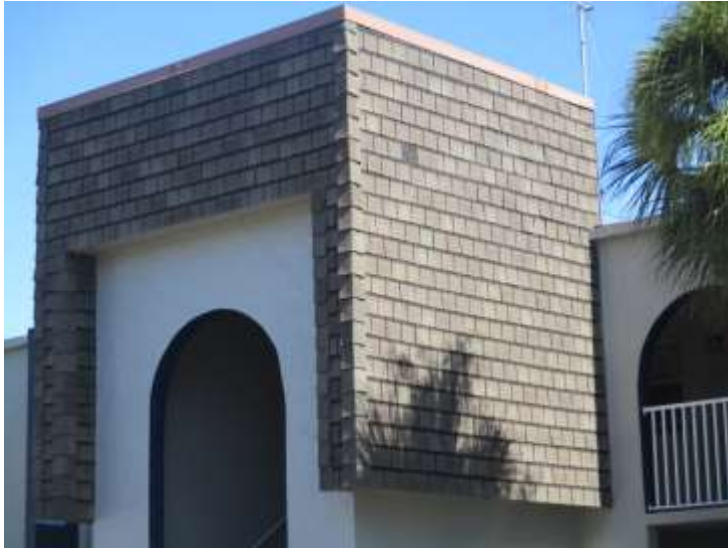
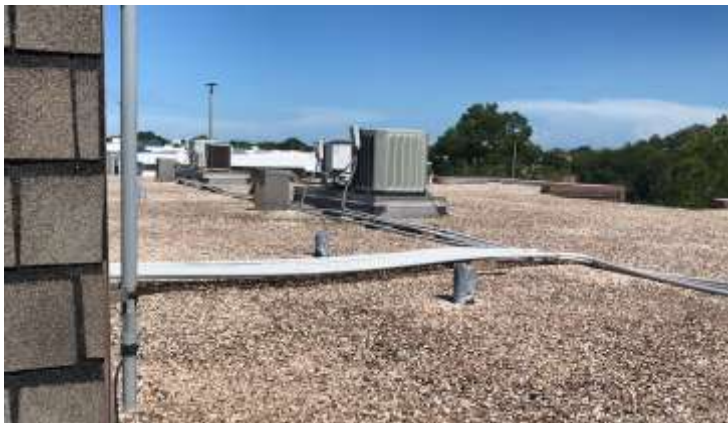
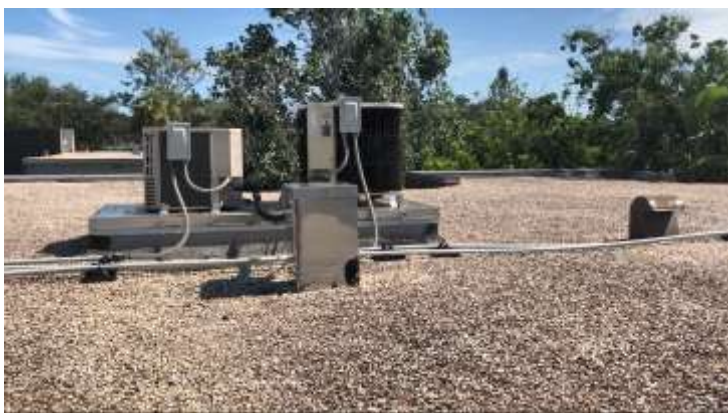
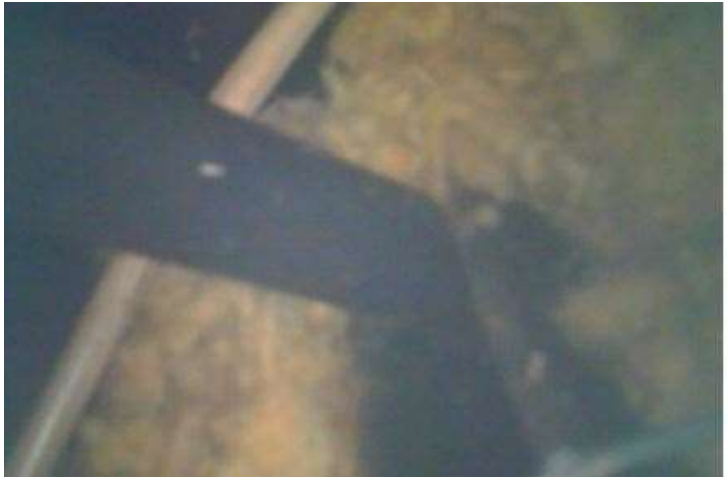
Roof Construction

3. **Roof Deck Attachment:** **Other**
Comments: Inspection verified a roof deck composed of lightweight concrete gypsum panels supported by steel bar joists.

4. **Roof to Wall Attachment:** **Structural**
Comments: Inspection verified a roof-wall connection composed of steel bar joists structurally connected to the wall/support system.

5. **Roof Geometry:** **Flat Roof**
Comments: Inspection verified a flat roof shape.
6. **SWR:** **No**
Comments: Secondary water resistance does not apply to light weight concrete roof decks.
