COMMERCIAL WINDSTORM MITIGATION REPORT (OIR-B1-1802)

Key Manor Condominium Association, Inc.
3146 29th Ave N, Building H, Units 101-105, 201-205
St. Petersburg, FL 33713

As of 7/22/2019
FPAT File# MUD1913508

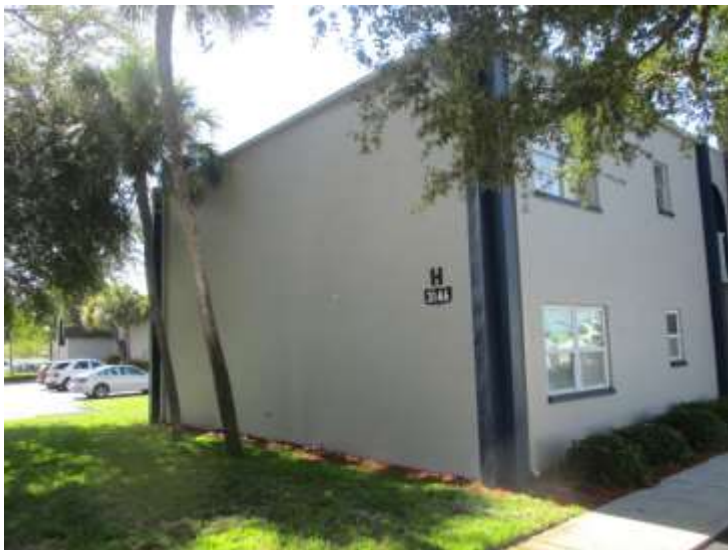
Exterior Elevation

5. **Roof Geometry:** **Flat Roof**
Comments: Inspection verified a flat roof shape.
6. **SWR:** **No**
Comments: Secondary water resistance does not apply to light weight concrete roof decks.

7. **Opening Protection:** **None or Some Glazed Openings**
Comments: Inspection verified no opening protection.

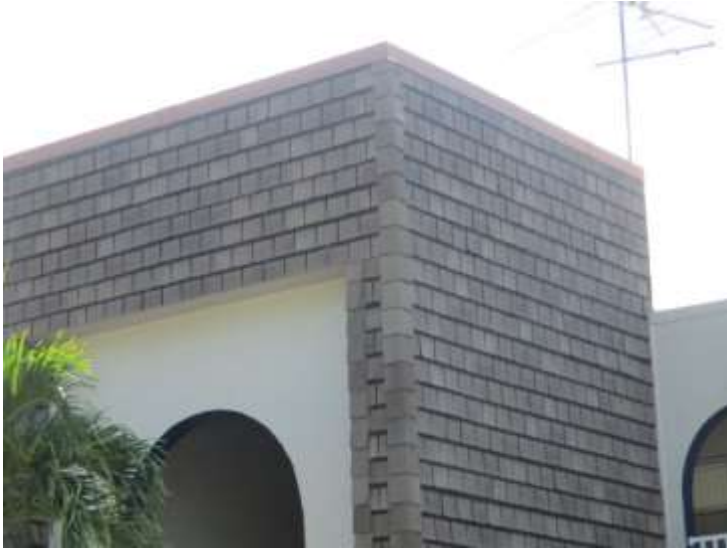
Roof Construction

3. **Roof Deck Attachment:** **Other**
Comments: Inspection verified a roof deck composed of lightweight concrete gypsum panels supported by steel bar joists.

4. **Roof to Wall Attachment:** **Structural**
Comments: Inspection verified a roof-wall connection composed of steel bar joists structurally connected to the wall/support system.
