# Key Manor Condos Building A Wind Mitigation

## Wind Mitigation Inspection Report

By: Fair Wind Inspections Inc.

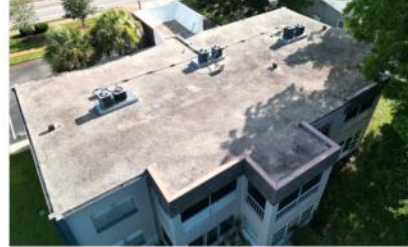
Geometry Picture:

Roof Geometry:	Flat		
Total Non-Hip	N/A	Total Perimeter:	N/A
Less Than 2:12:	100%	Total Area:	100%

Entire roof structure is flat concrete
