Key Manor Condos Building D Wind Mitigation

Wind Mitigation Inspection Report

By: Fair Wind Inspections Inc.

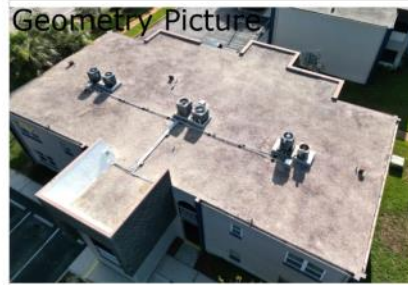
Geometry Picture

Roof Geometry:	Flat		
Total Non-Hip	N/A	Total Perimeter:	N/A
Less Than 2:12:	100%	Total Area:	100%

Roof surface is in good condition

Entire roof structure is flat concrete
