Key Manor Condos Building E Wind Mitigation

Wind Mitigation Inspection Report

By: Fair Wind Inspections Inc.

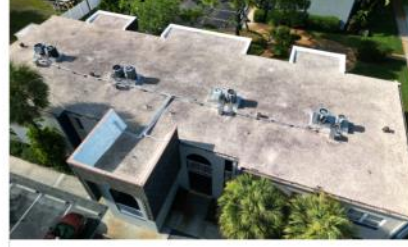
Geometry Picture

Roof Geometry:	Flat		
Total Non-Hip	N/A	Total Perimeter:	N/A
Less Than 2:12:	100%	Total Area:	100%

Roof surface is in good condition

Entire roof structure is flat concrete
