Key Manor Condos Building F Wind Mitigation

Wind Mitigation Inspection Report

By: Fair Wind Inspections Inc.

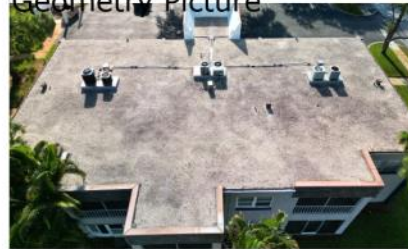
Geometry Picture

Roof Geometry:	Flat		
Total Non-Hip	N/A	Total Perimeter:	N/A
Less Than 2:12:	100%	Total Area:	100%

Entire roof structure is flat concrete
