Key Manor Condos Building G Wind Mitigation

Wind Mitigation Inspection Report

By: Fair Wind Inspections Inc.

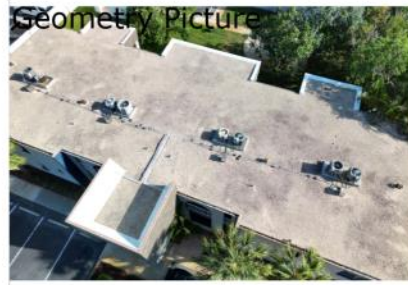
Geometry Picture

Roof Geometry:	Flat		
Total Non-Hip	N/A	Total Perimeter:	N/A
Less Than 2:12:	100%	Total Area:	100%

Roof surface is in good condition

Entire roof structure is flat concrete
