Key Manor Condos Building C Wind Mitigation

Wind Mitigation Inspection Report

By: Fair Wind Inspections Inc.

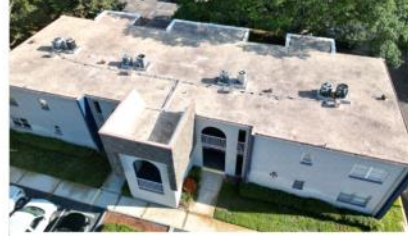
Geometry Picture

Roof Geometry:	Flat		
Total Non-Hip	N/A	Total Perimeter:	N/A
Less Than 2:12:	100%	Total Area:	100%

Entire roof structure is flat concrete
